The
LaQUE CENTER
FOR CORROSION TECHNOLOGY, INC.

**SEAWATER CREVICE CORROSION RESISTANCE OF
STAINLESS STEELS COATED WITH
SILANE AND ANTIFOULING PAINT SYSTEMS**

**FINAL REPORT
CONTRACT N00014-01-C-0177**

August 2002

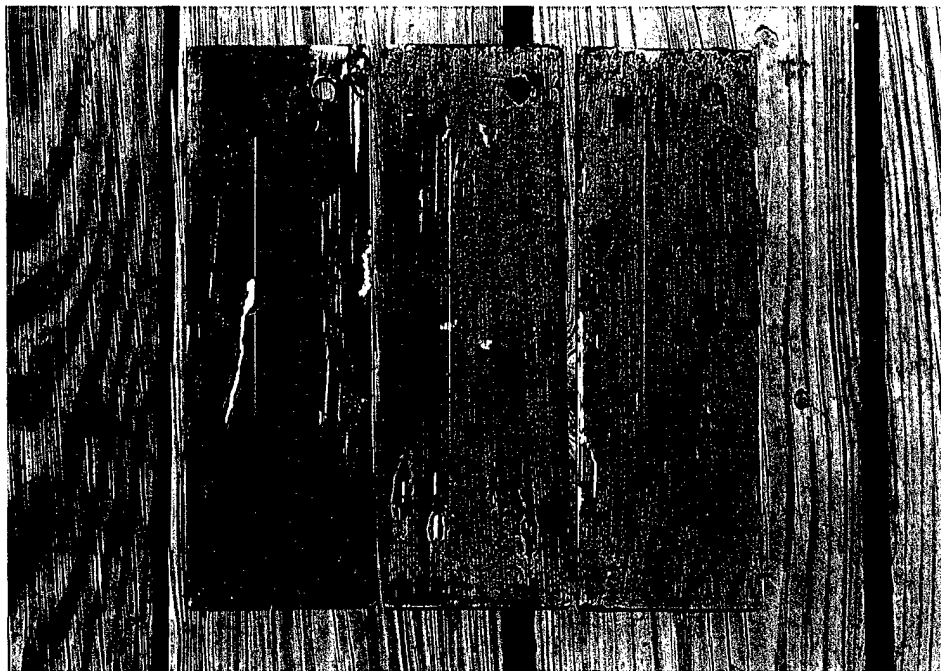
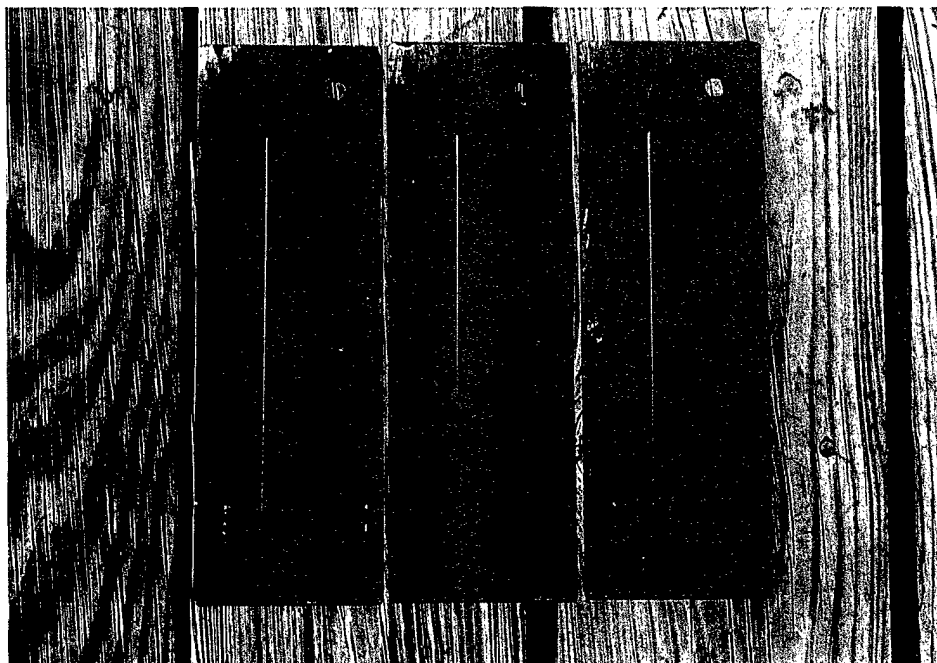
Figure ES-3. Comparative views of fully coated + scribed specimens exposed for nine months.
(Left-right: pretreated with Silane A, B and C)

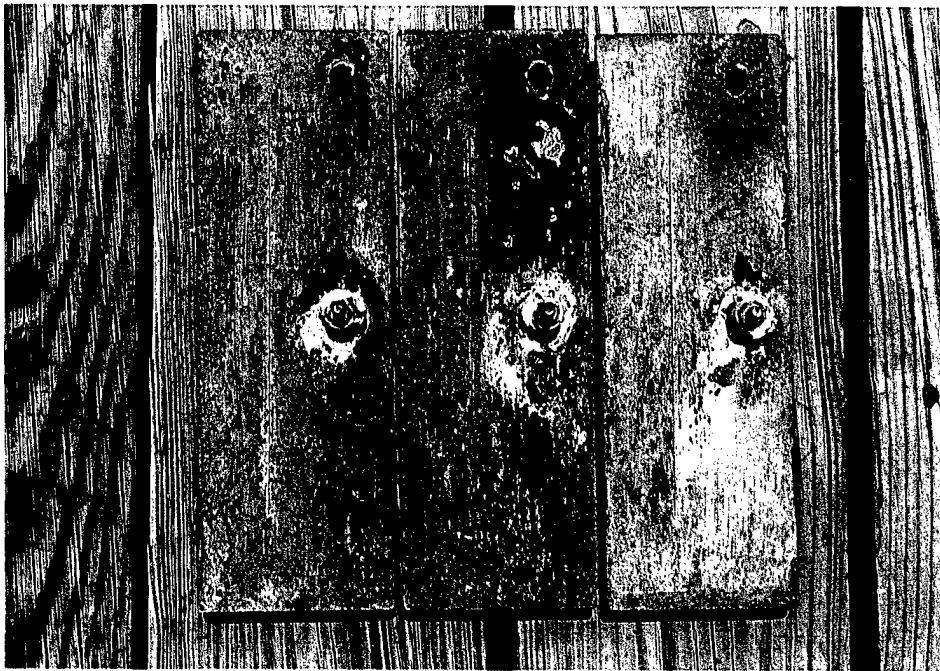
2609-04-018-22

Figure ES-4. Representative view of fully coated + scribed specimens exposed for full nine months with zinc anode attachments.
(Shown N08367 (left-right) pretreated with Silane A, B and C.)

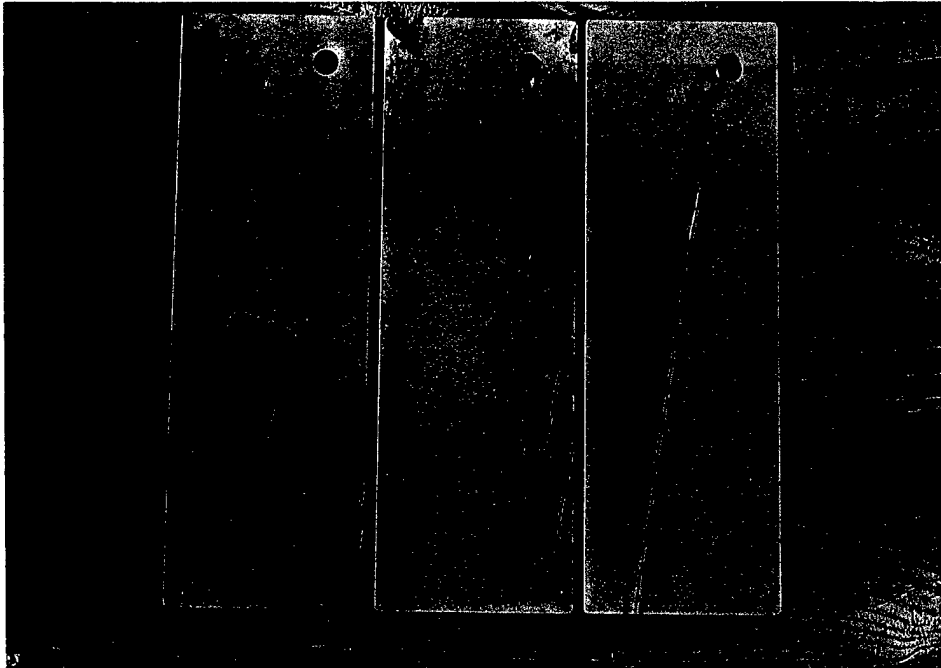
In contrast to the above, S31603 specimens partially coated with silane treatments A, B, and C exhibited extensive pitting in coated and non-coated areas, including the edges, but no crevice attack per se. In the absence of any extensive crevice corrosion, initiated pits propagated with the assist of gravity (Figure 5).

FIGURE 5 – View of partially cleaned S31603 specimens with 80% silane coverage (left to right: Silane A, B and C).

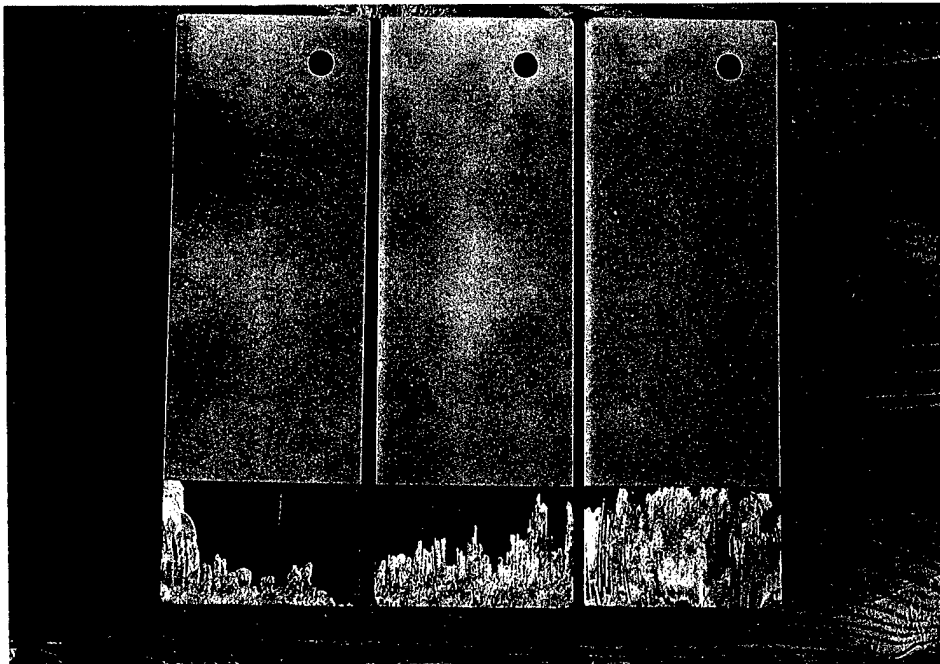
All S31603 specimens with 20% of the surfaces coated with silane + ablative Cu exhibited crevice-like attack. However, in contrast to the epoxy coated controls, the attack appeared to propagate inward from the edges and other initiation sites rather than from the primary interface with the bare metal. As shown by Figure 6, some influence of silane formulation on the overall extent of attack is apparent from the visual ranking $A < B < C$. Except for attack at apparent pit initiation sites, the attack beneath the silane + ablative Cu was relatively light, as contrasted with that found beneath the epoxy.

FIGURE 6 – After-cleaning view of S31603 specimens with 20% silane + ablative Cu (left to right: Silane A, B and C precoated)

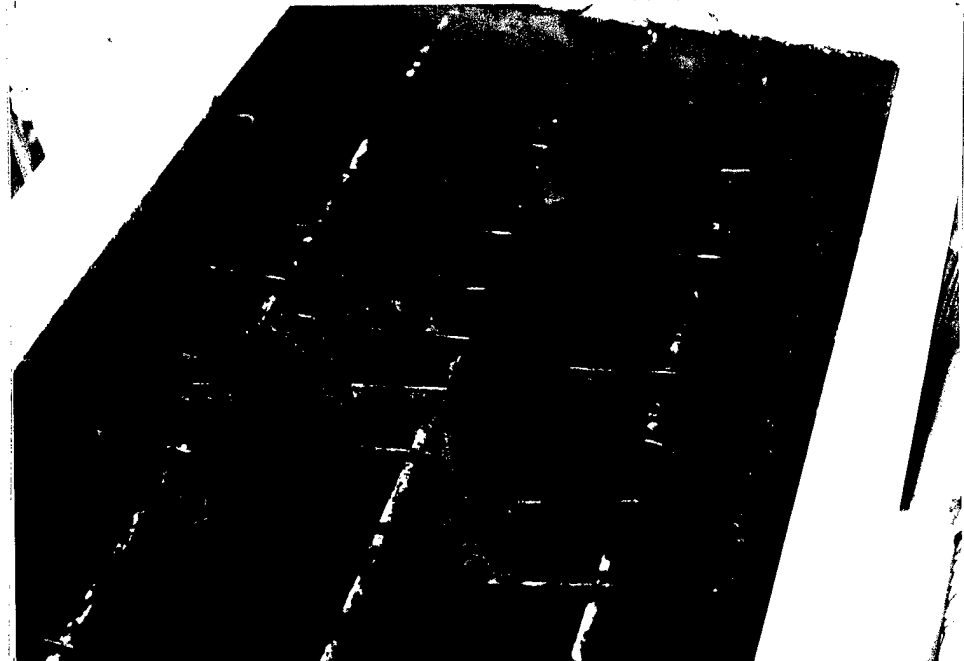
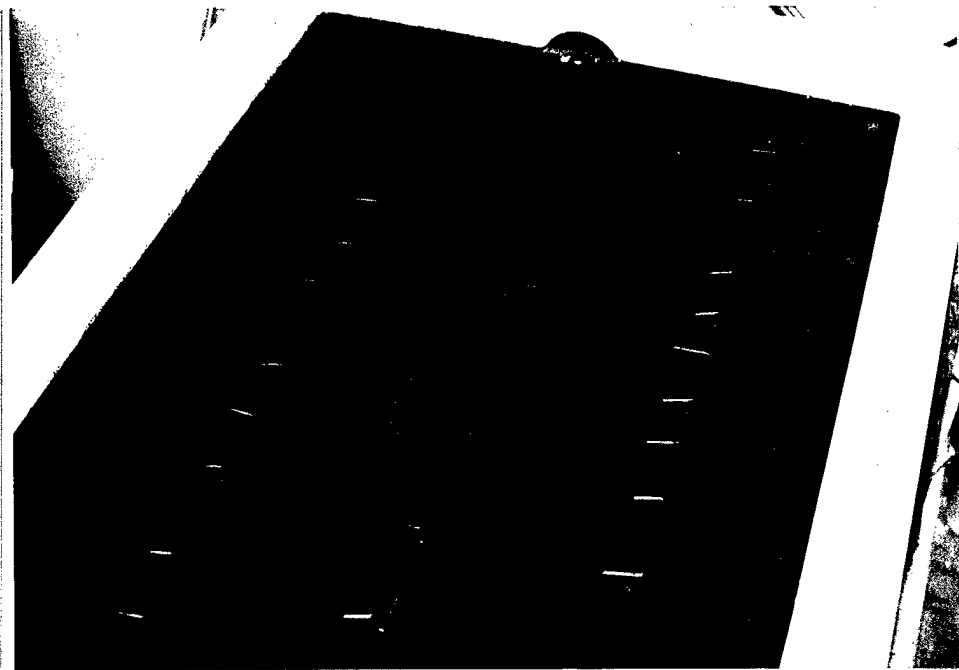
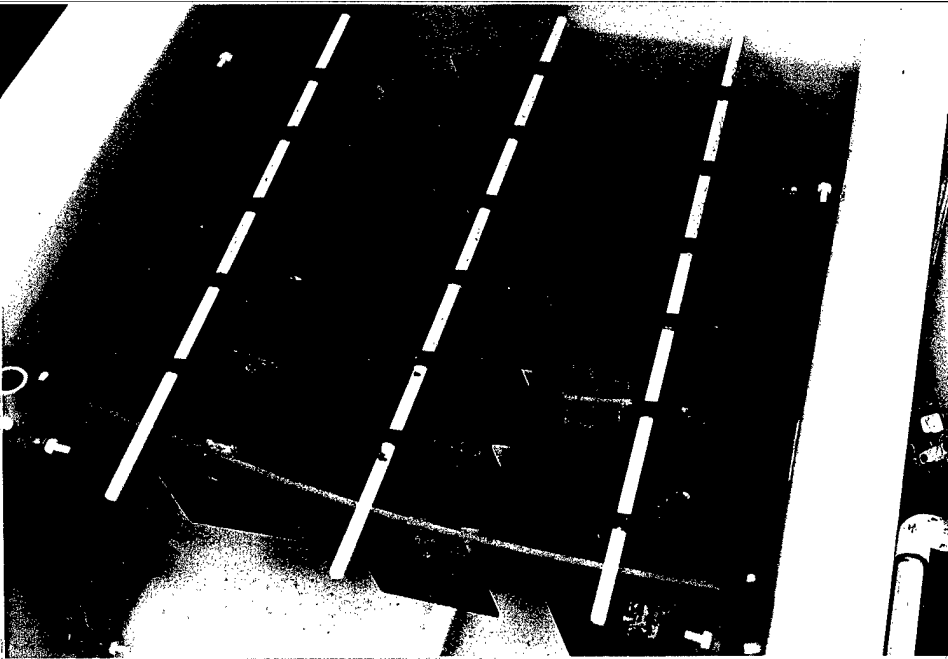
Figures 1.1 to 1.3 in Appendix 2 provides a series of photographs showing the in-situ appearance of the specimens remaining in Tanks 3, 4 and 5 for the full nine months. Figures 2.1 and 2.2 document the two affected sites found on the two epoxy coated N08367 specimens described above.

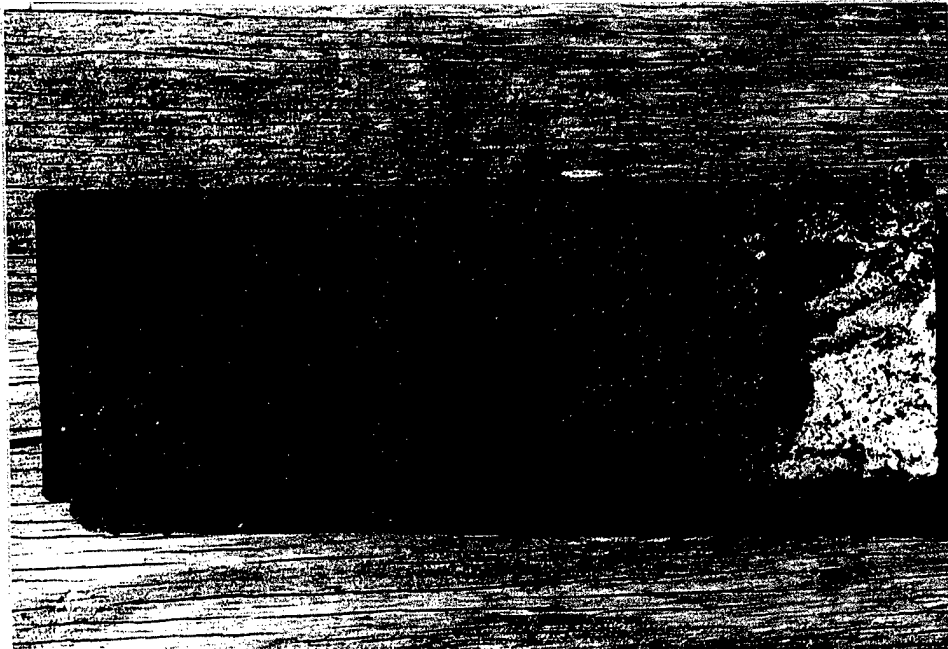
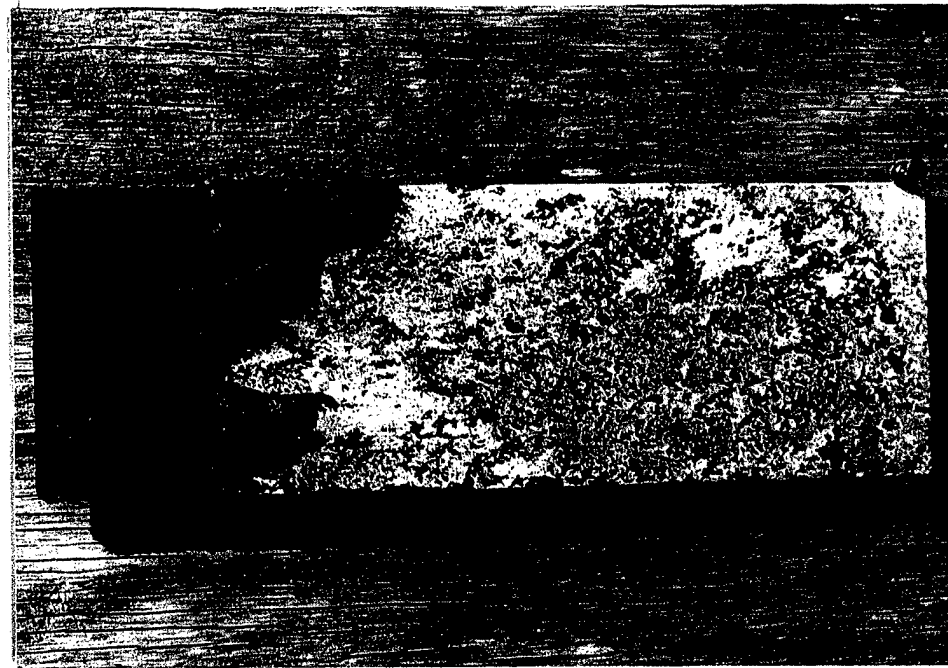
Photographs in Figures 3.1 to 9.3 in Appendix 2 provide representative as-removed views of the various S31603 specimens following nine months of continuous exposure. The letter designations F or B denote the front (code side) or back side of the indicated specimens. Extensive corrosion is clearly visible on the partially coated specimens. Somewhat less attack is shown for the fully coated + scribed specimens exposed without zinc anode protection. In addition to the obvious corrosion product, the specimens were found to be covered with marine slime and "floc" generated by the developed corrosion product. In addition, the exposed base metal portion, which is cathodic to the crevice area, of the partially coated specimens was covered with calcareous deposits to some extent or another. This deposition is more clearly observed on the surface of the brush and water cleaned specimens shown, for example, in Figure 3.3. During the course of subsequent acid cleaning, all 24 of S31603 specimens with epoxy and silane alone exhibited substantial effluence, indicative of calcareous deposition.

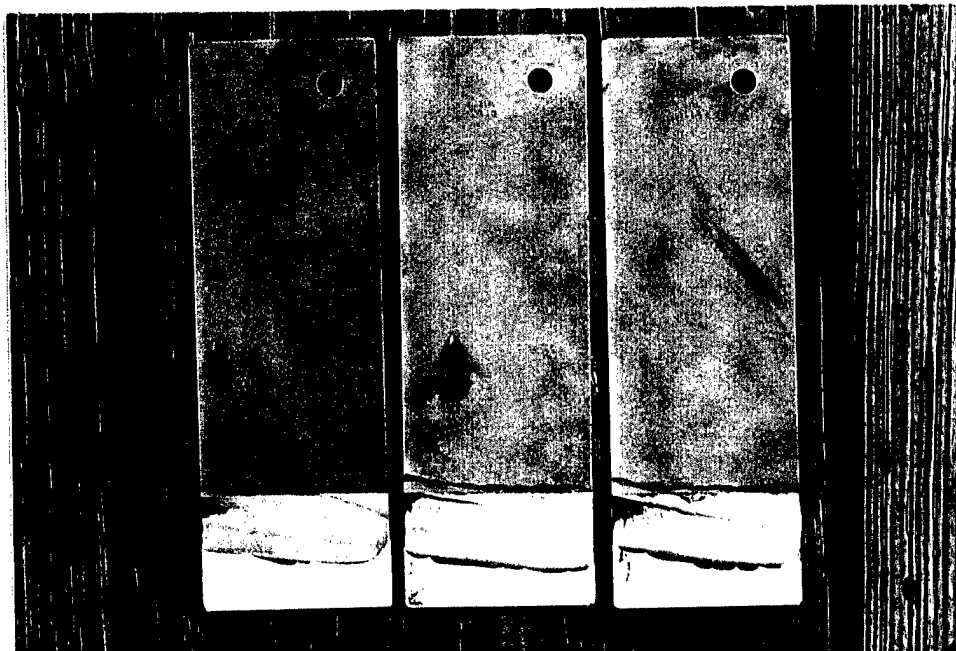
Figure 18.1 2609-04-019-4

Figures 18.1 and 18.2 (20%), and Figures 19.1 and 19.2 (80%) show the extent of crevice corrosion which developed beneath the epoxy coating on S31603 specimens in nine months. Figures 18.3 and 19.3, respectively, compare the "worst case" condition of the preceding with that found on corresponding specimens removed after only three months.

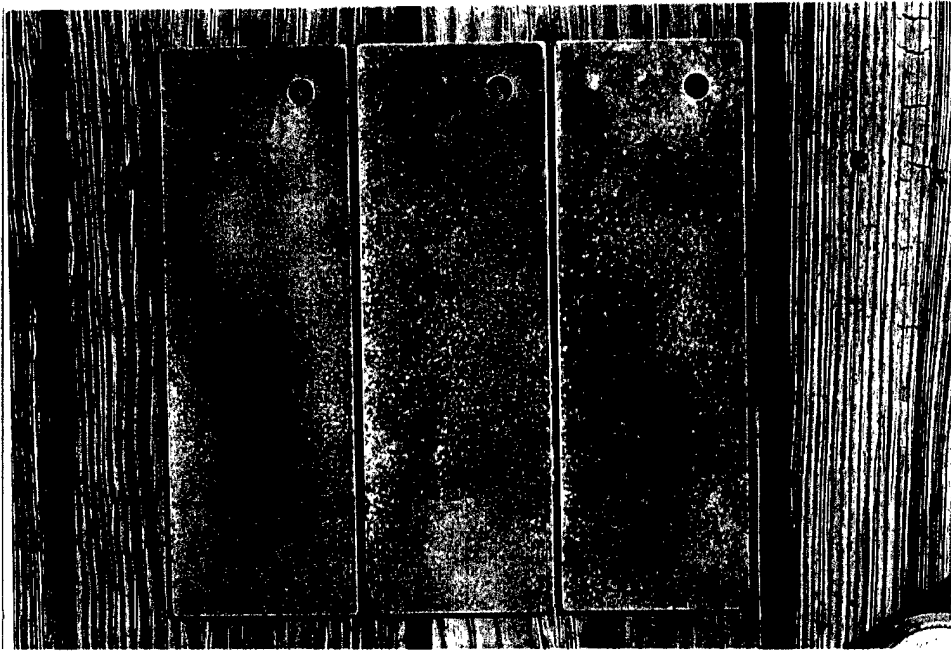
Figure 24.2 2609-04-021-1

In contrast to the above, final inspection of the 18 partially coated N087367 specimens (Figures 24.1 to 25.3) revealed no evidence of corrosion within the areas coated (20% and 80%)
